Case Report

MANAGEMENT OF CUSPAL FRACTURE USING A CERAMIC ONLAY

In this case report, a maxillary molar with a non-functional cusp that had been fractured has been replaced with a ceramic onlay and cemented with resin adhesive.

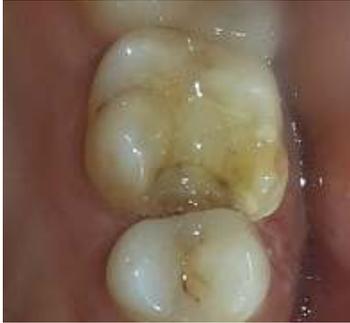
Intraoral examination revealed a fracture of the mesiobuccal cusp including the mesial marginal ridge of the upper left first molar. (#26). (Figure 1, 2). An electric pulp test (EPT) test was done to determine the vitality of this tooth which was found to be positive, and she reported no discomfort. She only complained of hypersensitivity when consuming hot or cold drinks. An x-ray examination of #26 revealed no caries or pulpal involvement. The supporting bone was intact without periodontal ligament widening or an apical lesion.

Figure 1: Occlusal view showing fractured mesiobuccal cusp of #26

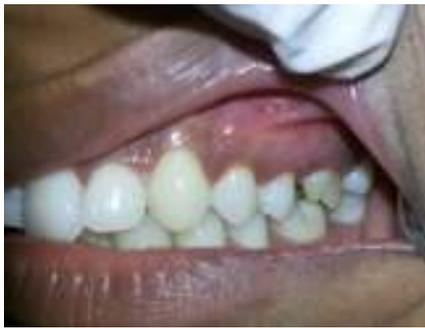
Figure 2: Buccal view showing fractured mesiobuccal cusp of #26

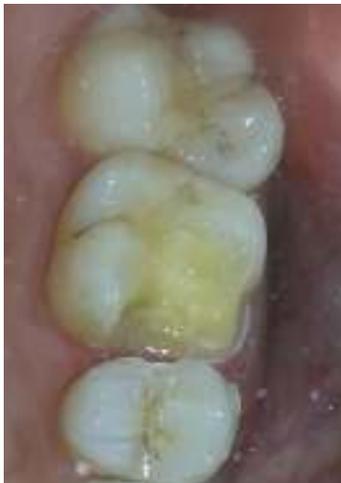
Figure 3: Occlusal view showing prepared tooth #26

The cavity was prepared only along the original defect area, without placing any mechanical undercutting to weaken the tooth structure. All margins had a 90° butt-joint cavosurface angle. All line and point angles were rounded to avoid stress being concentrated on the restoration and tooth. (Figure 3, 4).

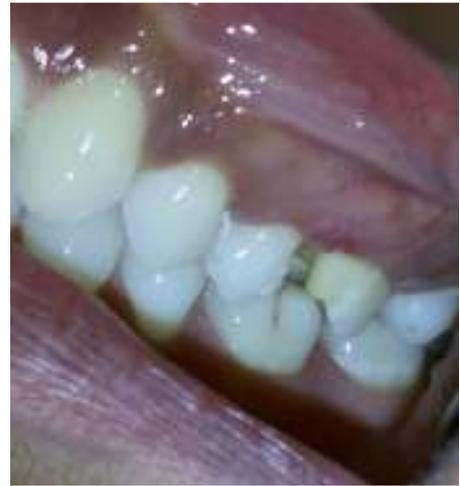
Figure 4: Buccal view showing prepared tooth #26

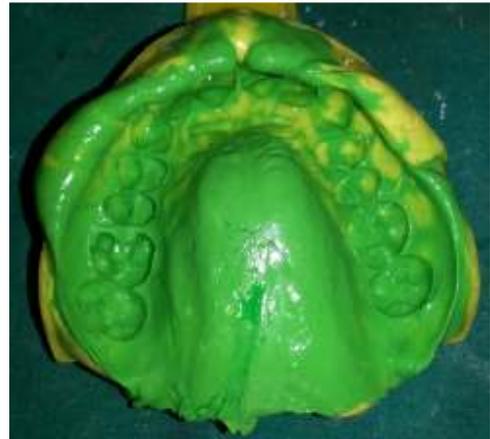
Figure 5: Elastomeric impression

The Impression was made using addition silicone elastomer using the single step impression technique (Putty and light body) (Figure 5).

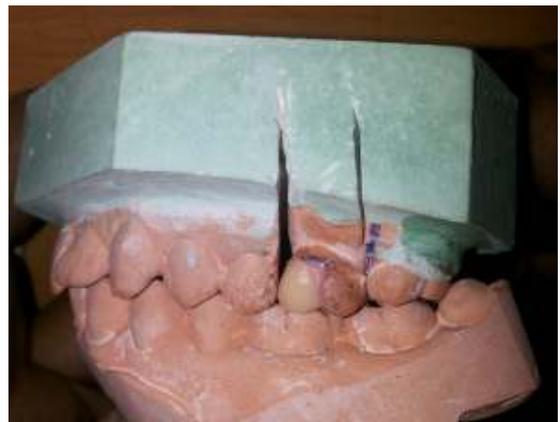
Figure 6: Wax pattern fabricated on die

The impression was poured in type IV dental stone. Die cutting was done and a wax pattern was fabricated (Figure 6) and invested. Pressing was done using “Multimat II touch and press” ceramic pressing machine.

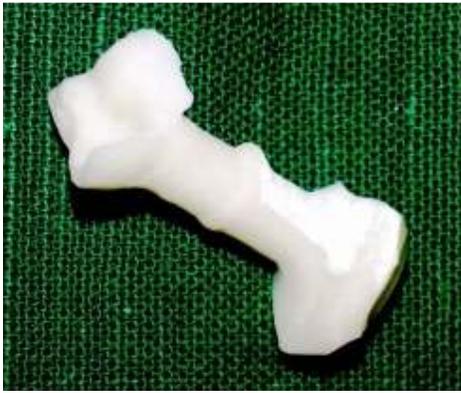
Figure 7: Divested onlay

The onlay was divested carefully and finished (Figure 7, 8, 9, 10). Then it was seated in the patient's mouth and the occlusion was checked for. Eccentric contacts were removed. The finished and polished ceramic onlay was cemented using a dual cure resin cement. The internal surface of the ceramic restoration was etched with 4% hydrofluoric acid (IPS Ceramic Etching Gel, IvoclarVivadent AG, Schaan, Liechtenstein) for 5 minutes, silanated with Mono- bond S (Variolink, IvoclarVivadent AG, Schaan, Liechtenstein), and covered with Helibond (Variolink, IvoclarVivadent AG, Schaan, Liechtenstein). The cavities were etched with 37% phosphoric acid, and a dentin-bonding agent was applied to the cavities (Syntac classic, IvoclarVivadent AG, Schaan, Liechtenstein). Then the ceramic restoration was seated using light pressure with a ball burnisher. Excess composite resin was removed with a thin- bladed composite instrument or an explorer. The cement was light-cured from each direction for an exposure of at least 60 seconds. Finishing and polishing of the restorations was done using a series of fine diamond instruments and 30-fluted carbide finishing burs under air-water spray (Figure 11, 12).

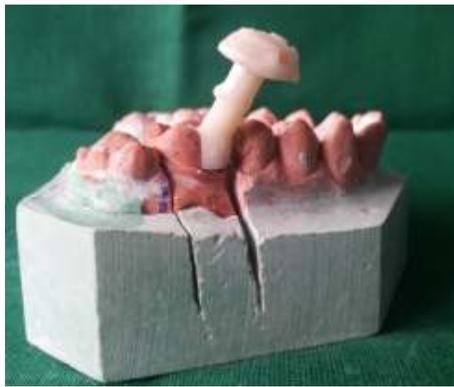
Figure 8: Divested onlay seated on die

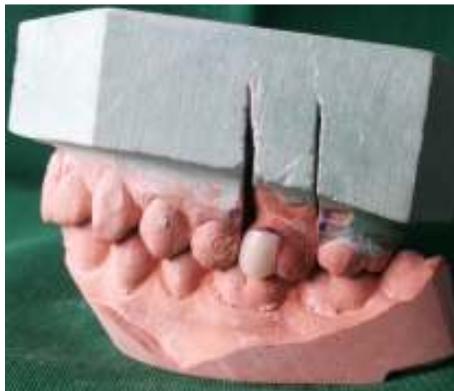
Figure 9 : Buccal veiv offinished onlay

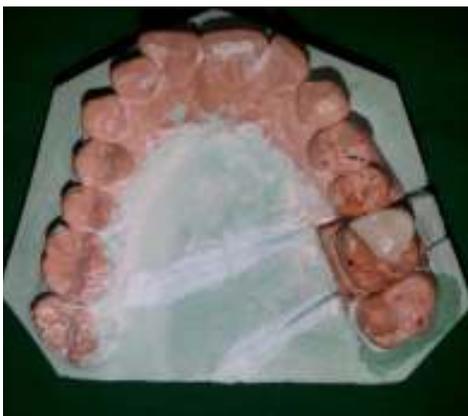
Figure 10 : Occlusal veiv of finished finished onlay

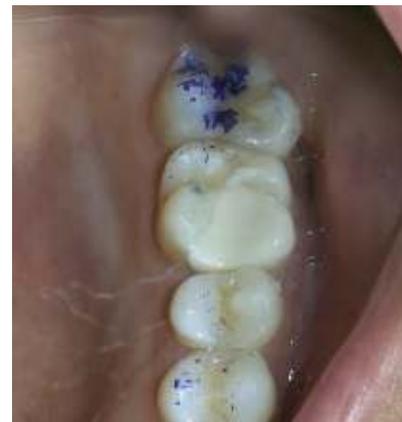
Figure 11: Occlusal view of cemented onlay

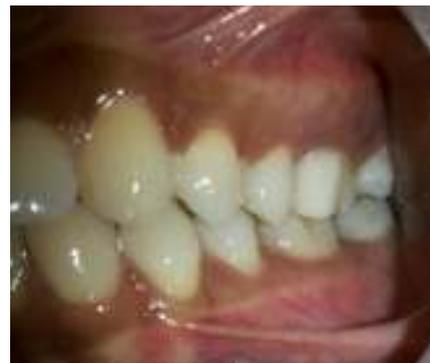
Figure 12: Buccal view of cemented ceramic onlay
